We have taken trail for 15 days found working satisfactorily. As per our suggestions discharge pipe has been modified by vendor (Photo attached).

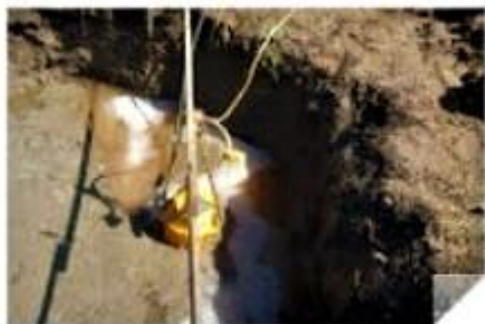
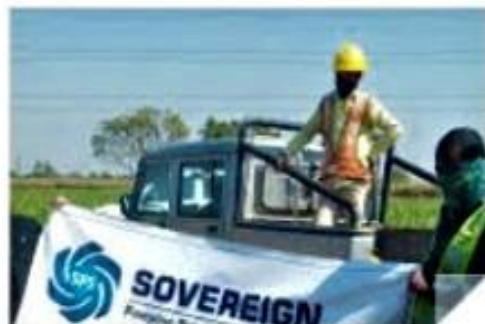
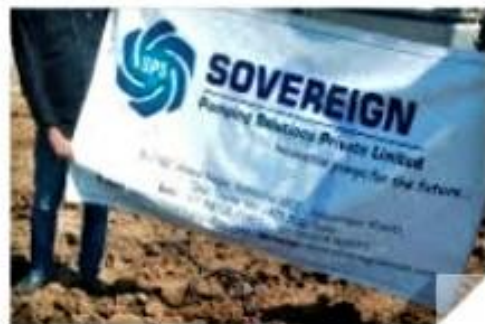
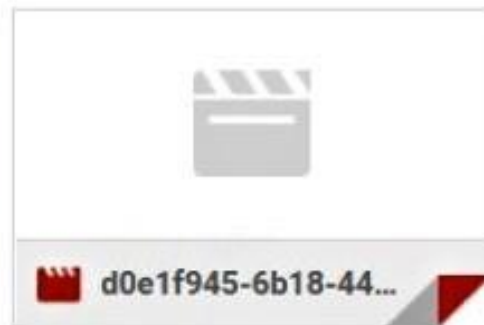
Current amps -14Amps

Discharge head polymer return Line -100Mtr
